## MEMORANDUM

**To:** Jason Gunter, U.S. Environmental Protection Agency  
**From:** Marcia Greenblatt  
**Date:** February 2014  
**Subject:** Big River OU-2 Visual Railroad Bed Survey  
**Project No.:** C816

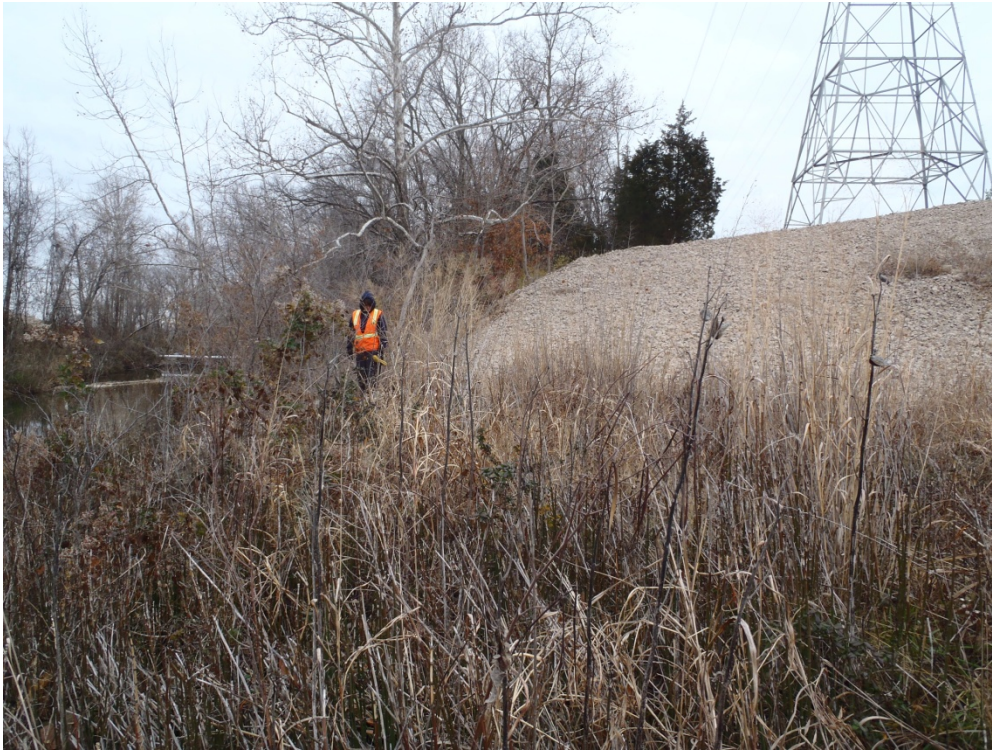
Photo 1: HRR001. Former trestle location over Flat River Creek

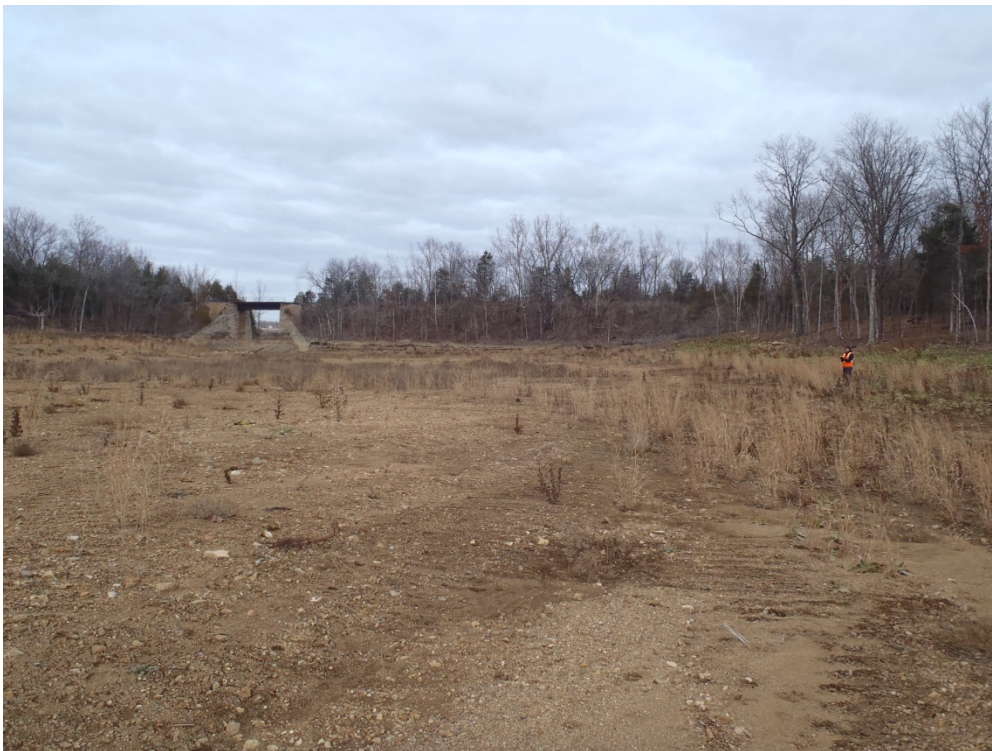
Photo 2: HRR002. Stable railroad bed

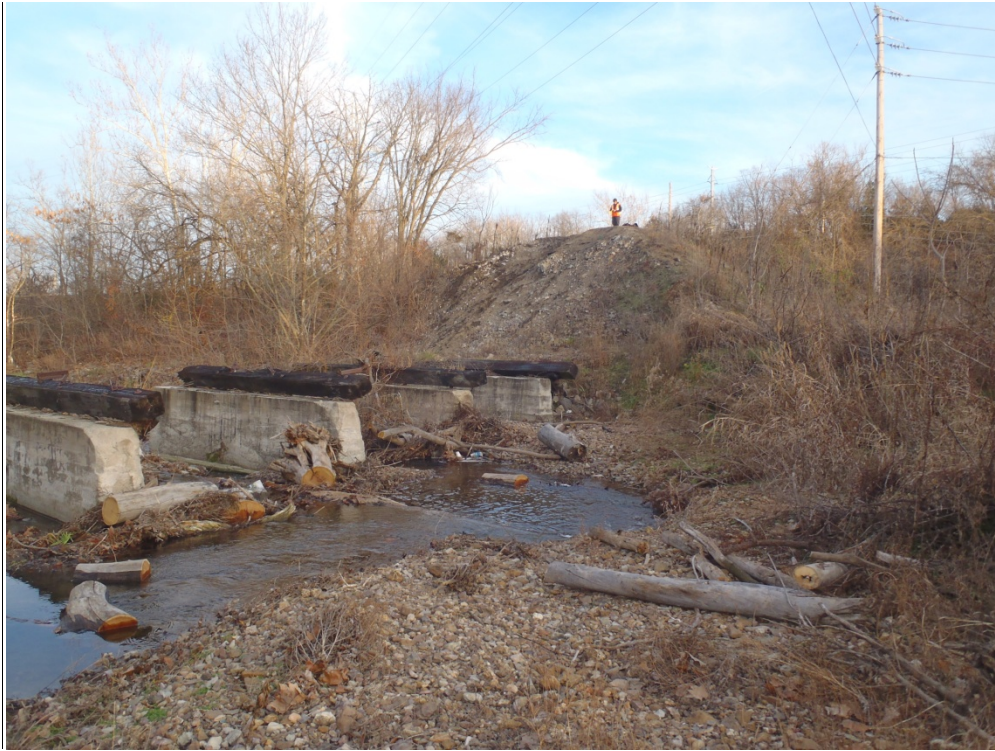
The remains of a former railroad trestle cross Flat River Creek at approximately river mile 5.3 (upstream of the confluence with Big River). A visual inspection of the trestle supports and the associated historic railroad bed was performed at survey location HRR003 (Figure 1). Erosion of the railroad bed along the eastern riverbank was observed; at the time of the survey eroded railroad bed material was not observed in Flat River Creek. An estimated 190 ft<sup>3</sup> of railroad bed material have eroded and this location may be an ongoing source of mining related material to Flat River Creek (Table 3).

Photo 3: HRR003. Former trestle location over Flat River Creek

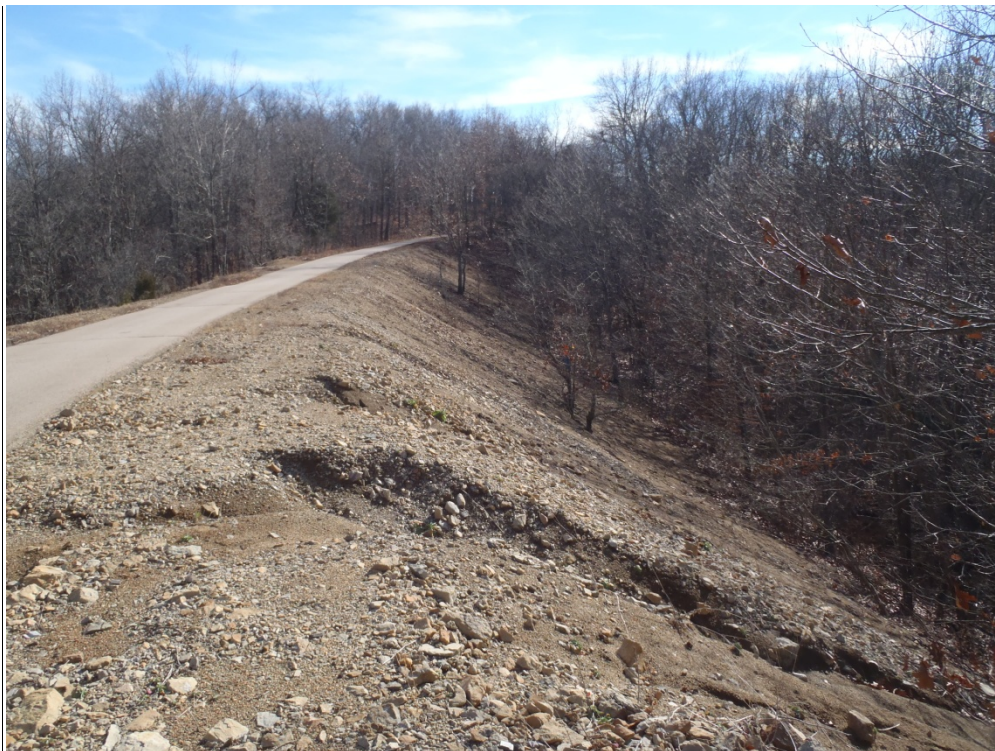
Photo 4: HRR004. Paved railroad bed with eroded areas on northwest slope

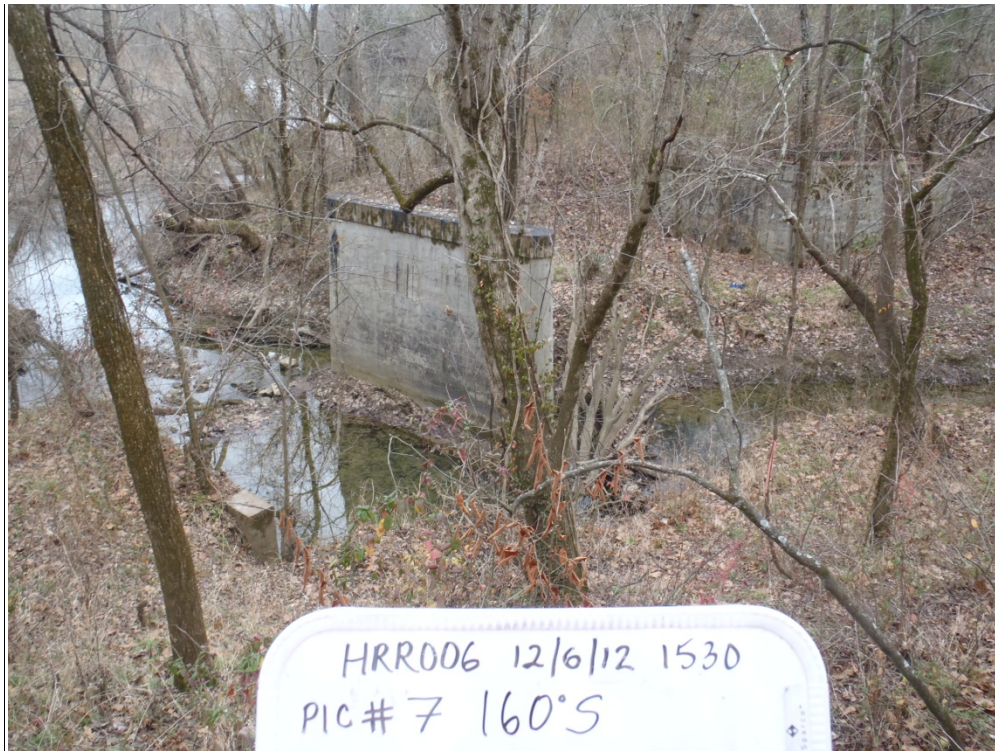
Photo 5: HRR006. Vegetated railroad bed and banks near former trestle crossing Eaton Branch

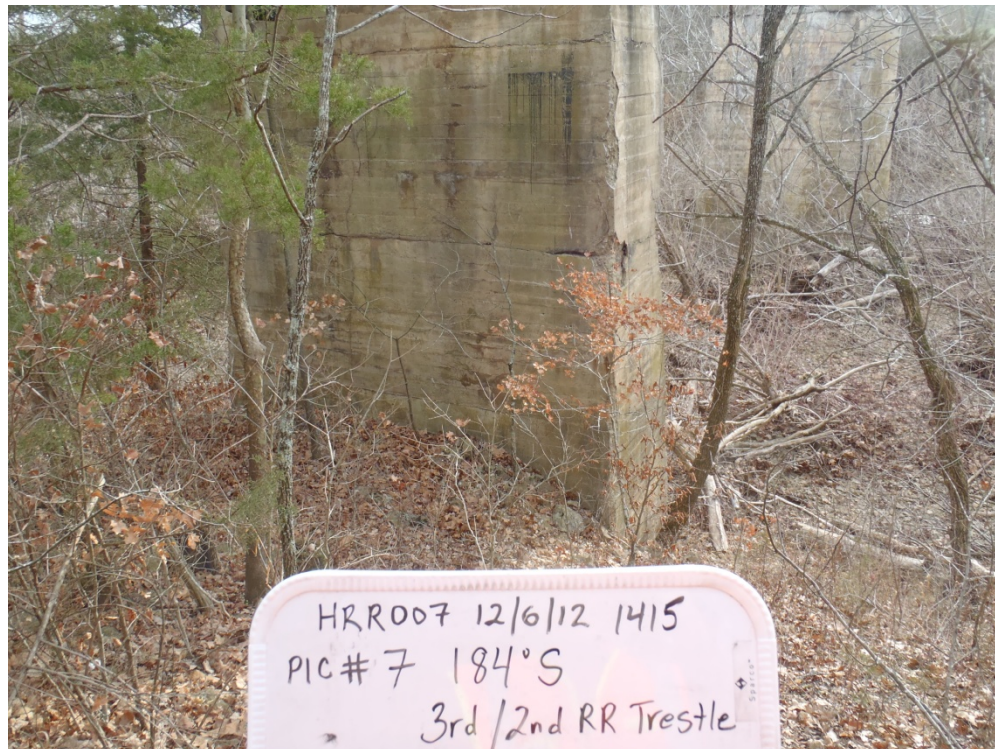
Photo 6: HRR007. Vegetated bank near former trestle crossing Big River

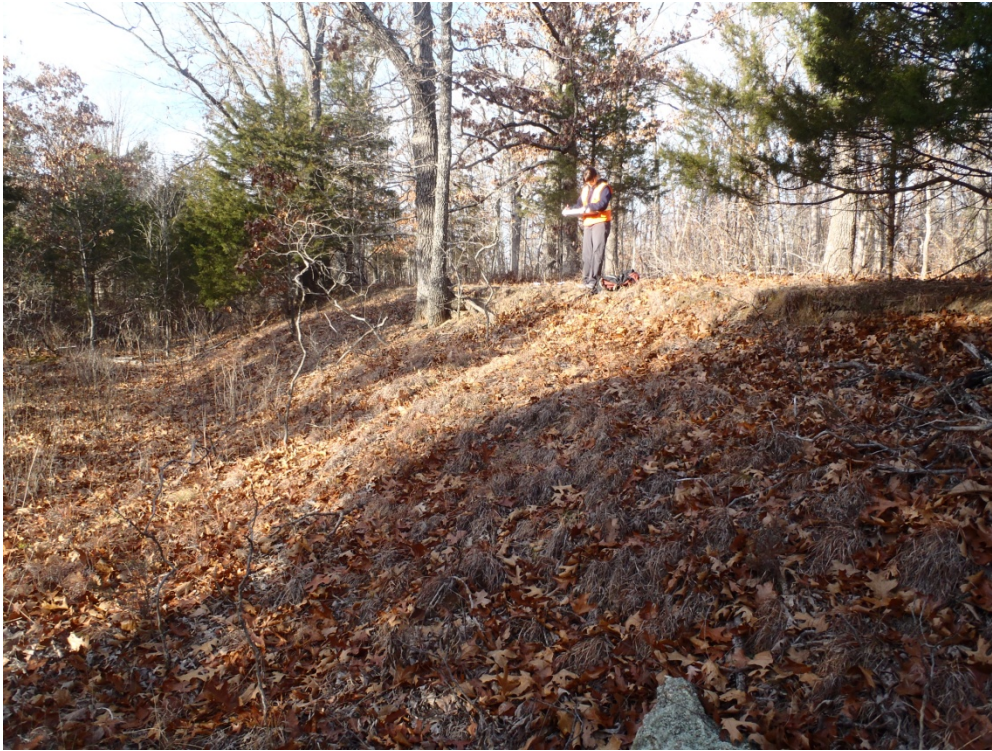
Three railroad survey sites, HRR008, HRR017, and HRR018, presented evidence of past erosion but appeared to be in stable condition. Survey location HRR008 had a large slumped area in the slope of the railroad bed that has since filled in with mature trees and other plantings. An old breach was observed in the railroad bed at HRR017 but the slope was noted to be stable. A small, unnamed tributary passes through a former railroad bed at survey location HRR018, however, the man-made breach in the railroad bed was well graded and evidence of ongoing erosion was not observed. These three sites do not appear to be an ongoing source of mining related material to Big River or its tributaries.

Photo 7: HRR008. Vegetated railroad bed above intermittent tributary to Harris Branch

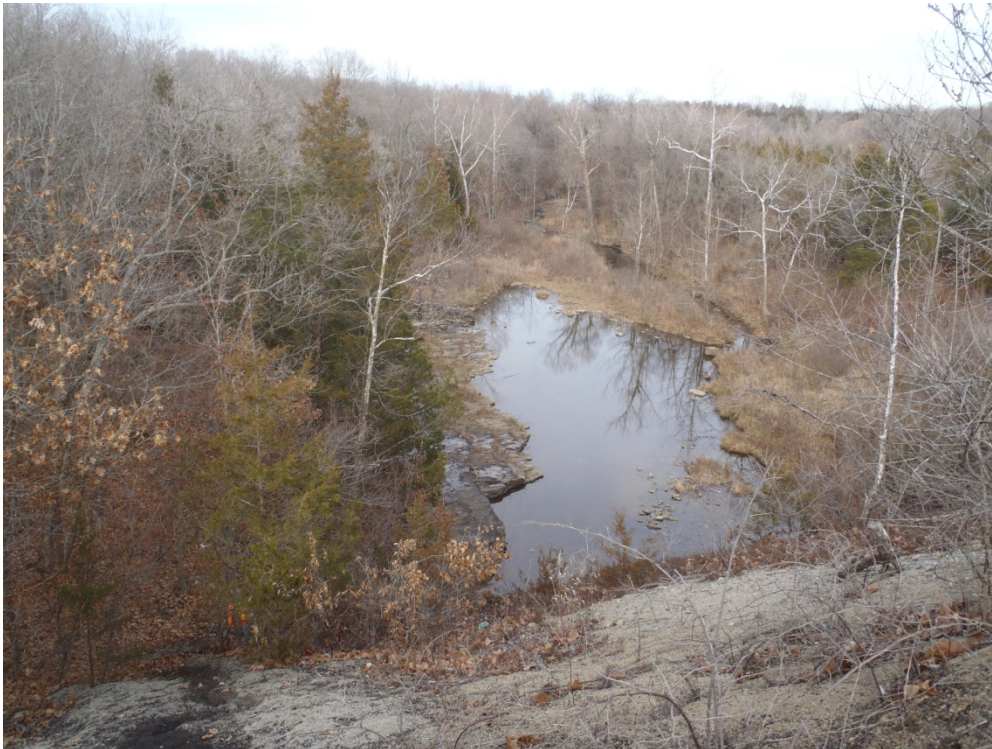
Photo 8: HRR009. Former railroad in foreground with Owl Creek below, facing downstream

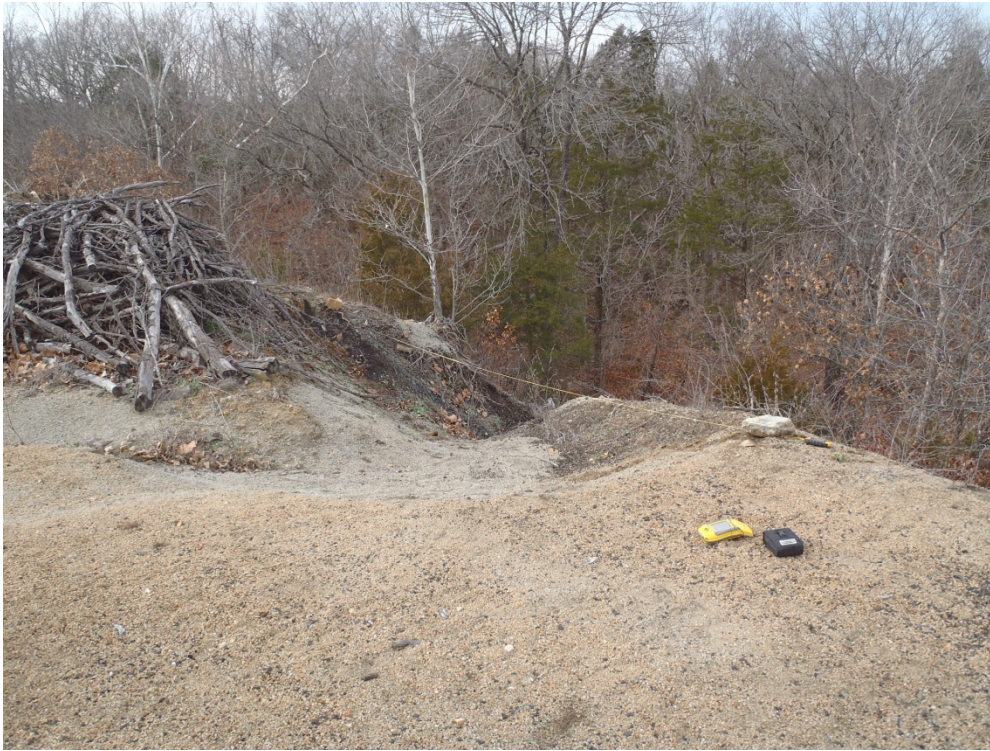
Owl Creek passes beneath the abandoned Mississippi River and Bonne Terre (MR and BT) Railroad through a cement box culvert. The railroad crossing and Owl Creek culvert were investigated as part of this visual survey (Station ID HRR009; Figure 1). An erosional area of the railroad bed was observed on the bank to the northwest of the culvert. Exposed mining-related material was observed on the northeastern slope of the culvert but did not appear to be eroding into the creek. Erosion of the railroad crossing was not observed upstream of the box culvert.

The railroad bed area northwest of the culvert was noted to contain loose material that enters Owl Creek. Survey measurements were used to estimate that 190 ft<sup>3</sup> of material has eroded from this portion of the railroad bed (Table 3). These results were consistent with a previous survey of St. Francois historical railroad beds in which chat from the railroad bed

Photo 9: HRR009. Eroded railroad bed on northwest slope of Owl Creek culvert

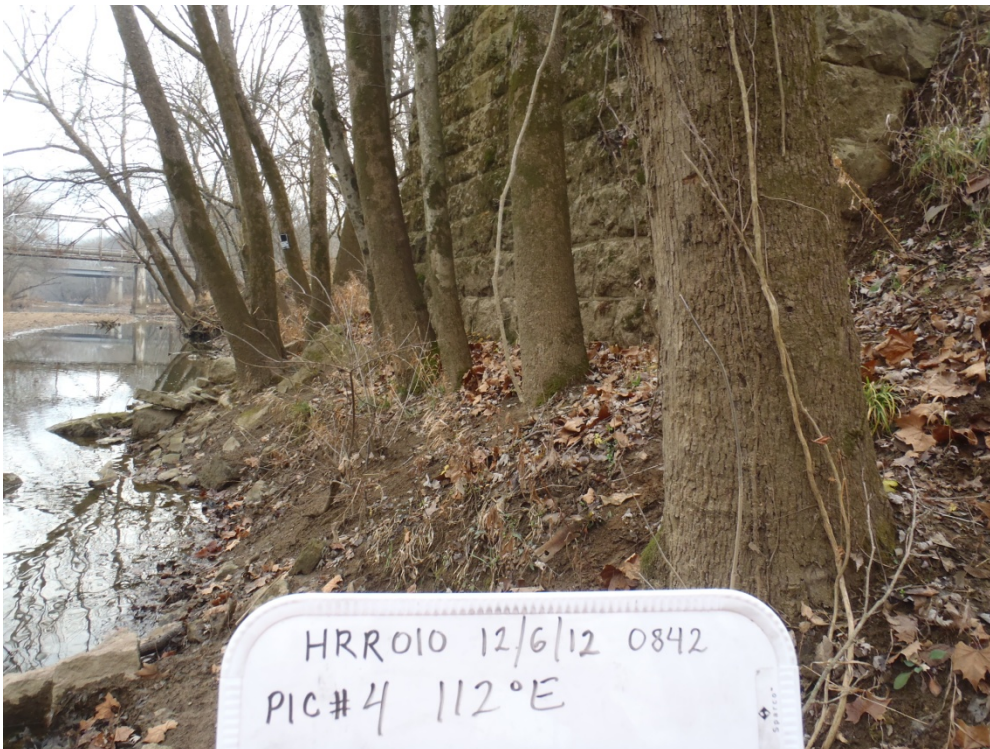
Photo 10: HRR010. Former trestle crossing Big River

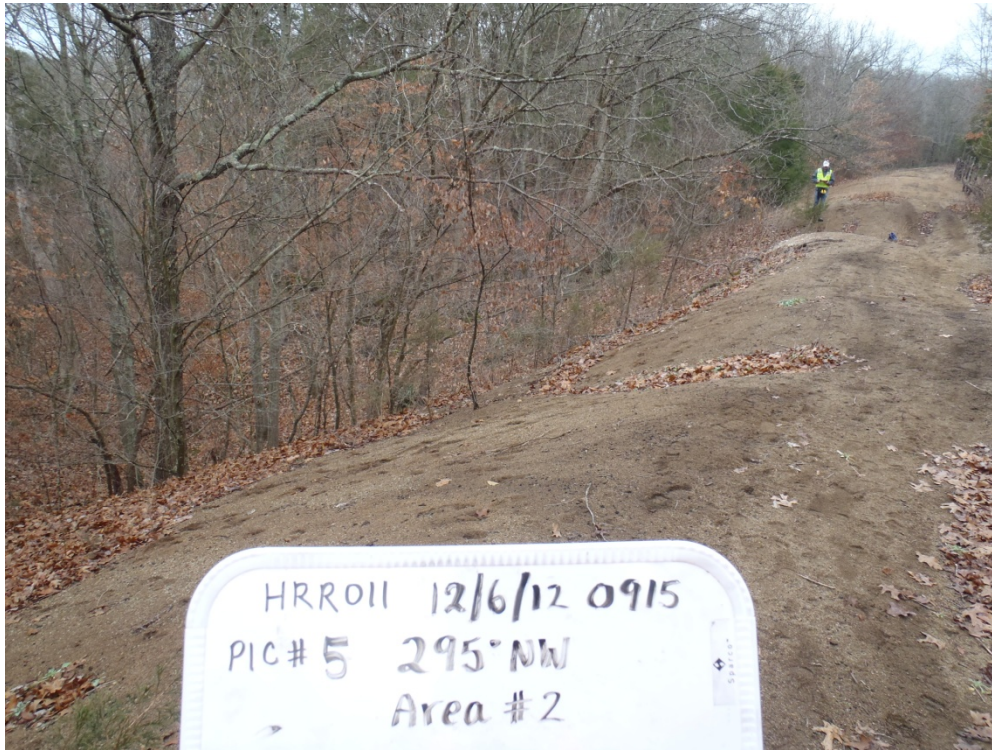
Photo 11: HRR011. Eroded areas on railroad bed slope facing Turkey Creek

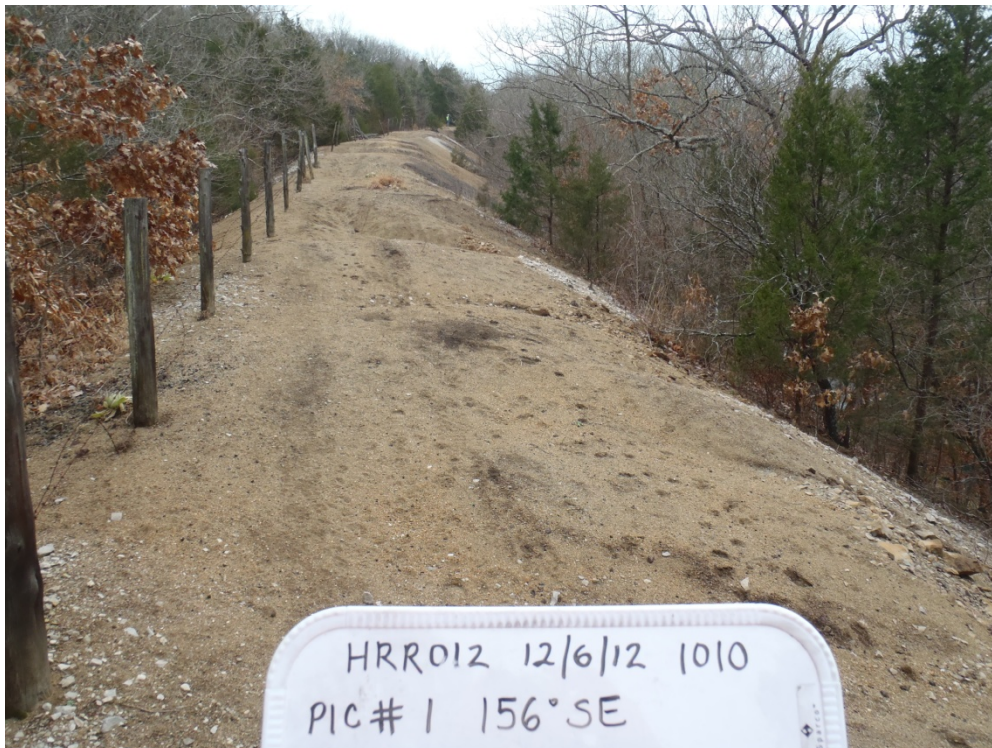
Exposed railroad bed material and eroded areas were observed at two survey sites along Turkey Creek, HRR011 and HRR012 (Table 2). The spatial extents of fifteen eroded areas along the railroad bed at HRR012 and one area at HRR011 were logged with a DGPS unit. The eroded areas slope downward onto the eastern bank of Turkey Creek, about 30 ft below. Depth measurements were not performed; however, a rough estimate of greater than 4,200 ft<sup>3</sup> of lost material was calculated from the measured surface area of the eroded areas and an assumed depth of 0.5 ft (Table 3). Several of the eroded areas at HRR012 were larger than any other observed during the survey and the railroad bed at HRR012 may be an ongoing source of material to Turkey Creek.

Photo 12: HRR012. Eroded areas on railroad bed slope facing Turkey Creek

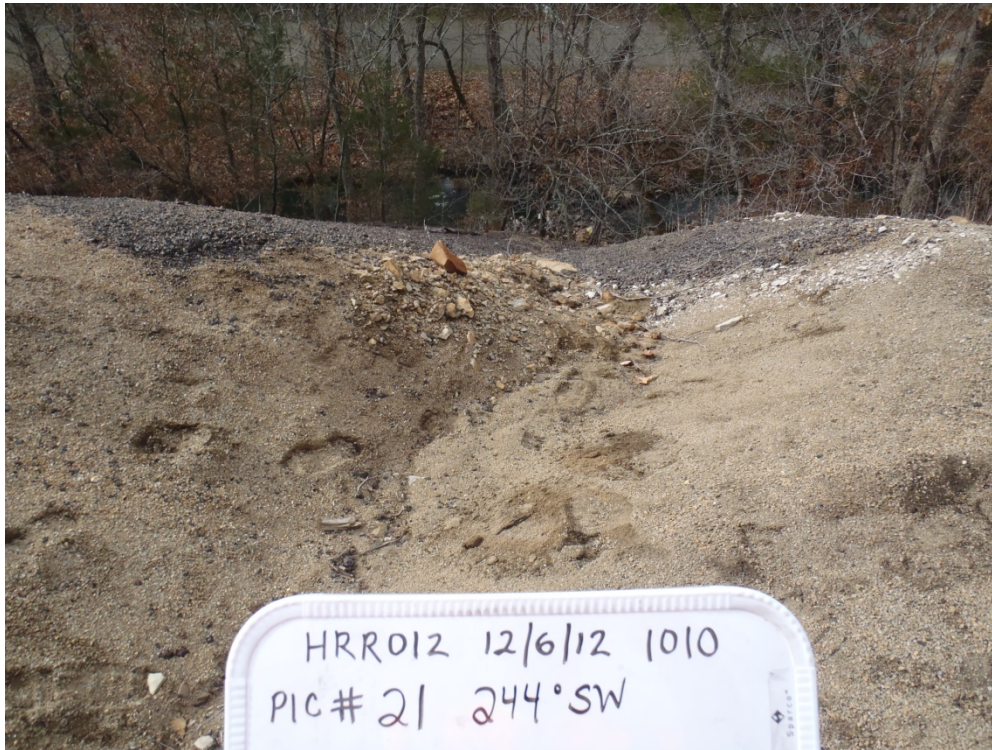
Photo 13: HRR012. Eroded area on railroad bed slope; Turkey Creek at base of slope

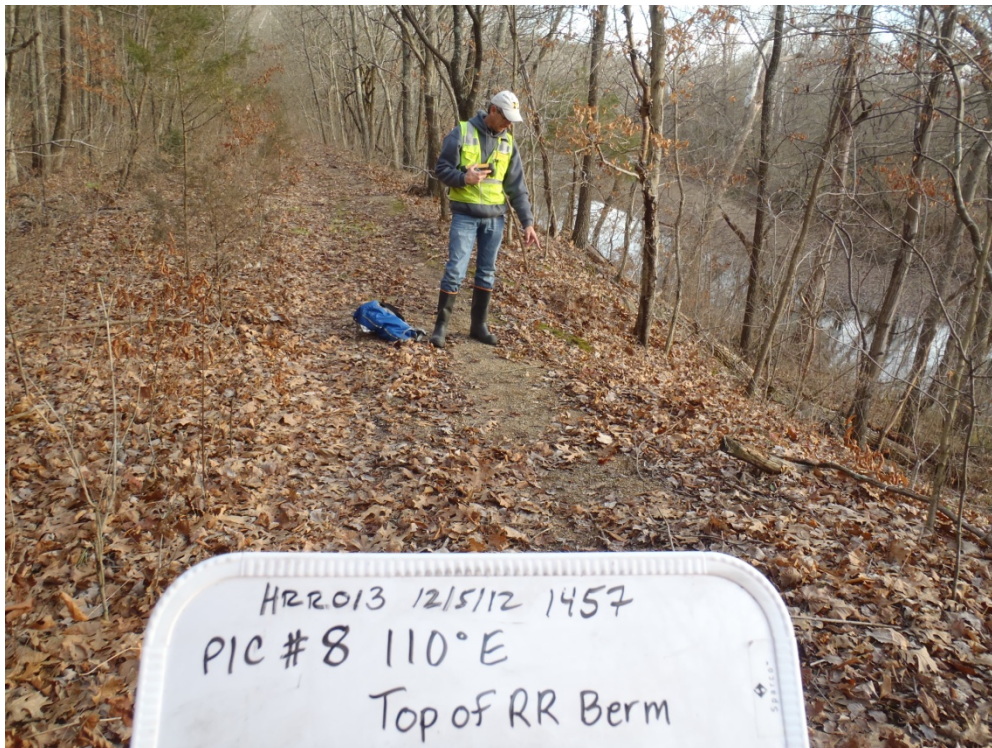
Photo 14: HRR013. Vegetated railroad bed slope leading to Big River

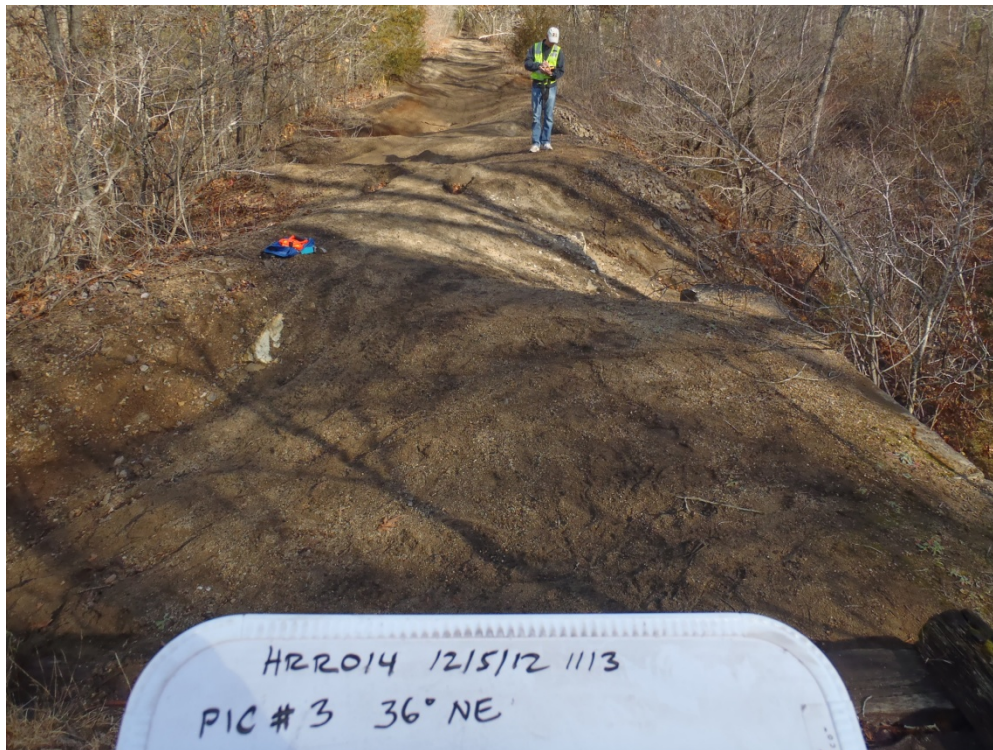
Photo 15: HRR014. Top of railroad bed above Bee Run

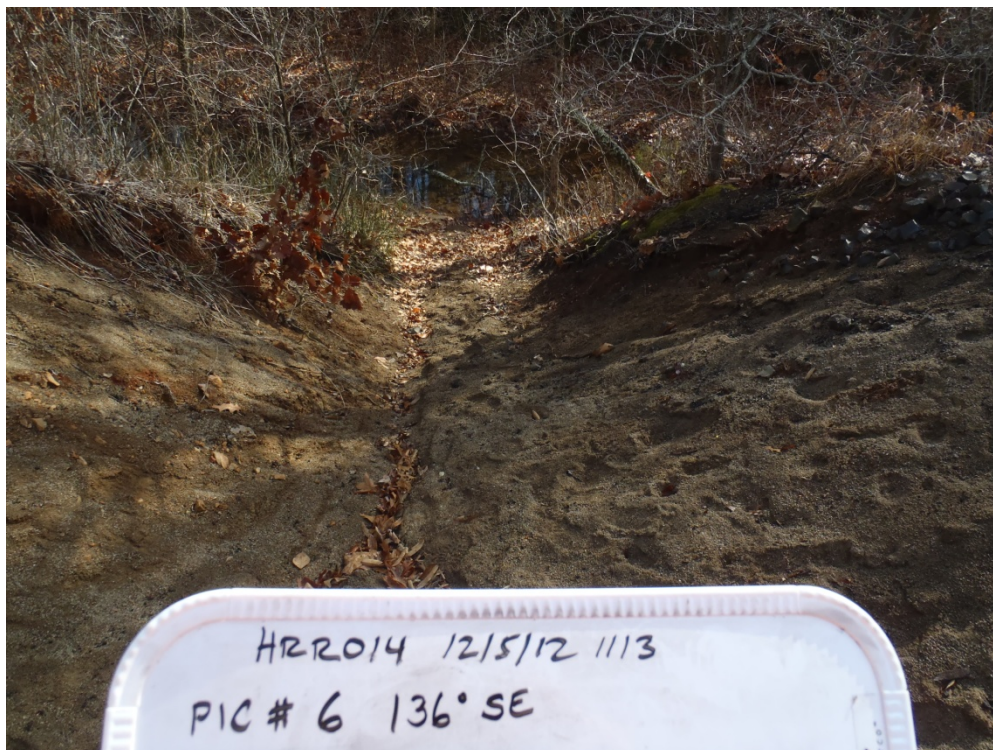
Exposed and erosional areas were observed at survey location HRR014, the site of an abandoned railroad bridge that crosses the tributary Bee Run (Figure 1). Off road vehicle

tracks were observed on the western slope of the railroad bed and may have led to the erosion of the railroad bed at this location. An erosional area on the eastern slope of HRR014 was observed to fan into Bee Run. Field measurements and an assumed depth of 0.5 ft were used to estimate that approximately 920 ft<sup>3</sup> of material had eroded from railroad beds that are within 50 ft of Bee Run, and it may be a minor ongoing source of material to the tributary.

Photo 16: HRR014. Eroded area leading to Bee Run

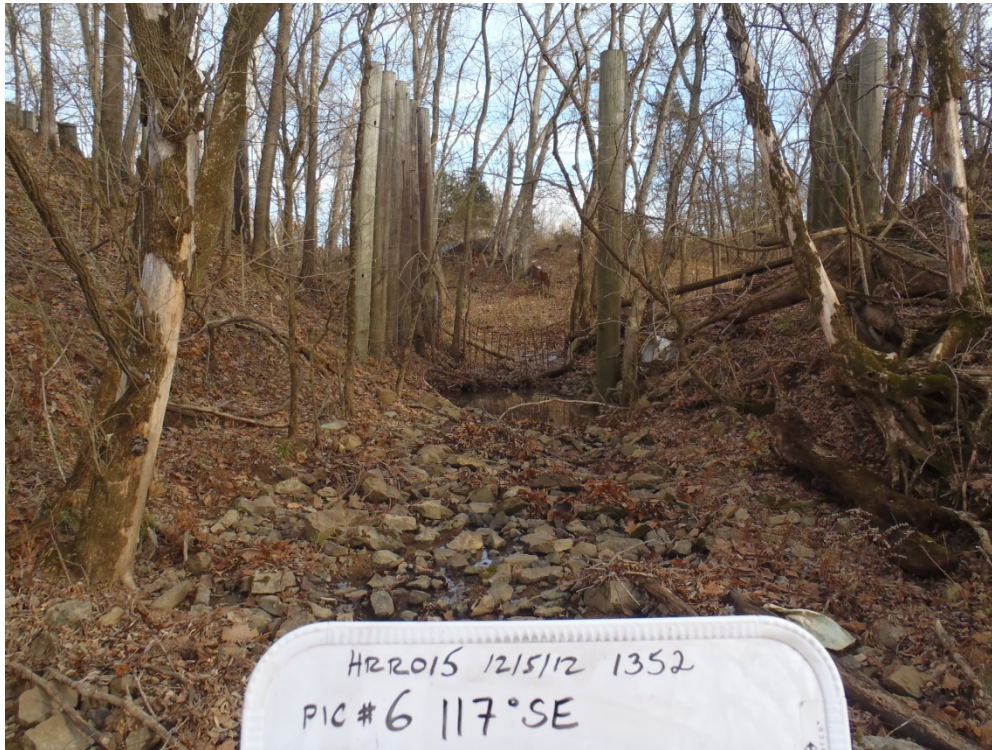
Photo 17: HRR015. Former trestle above perennial tributary to Big River

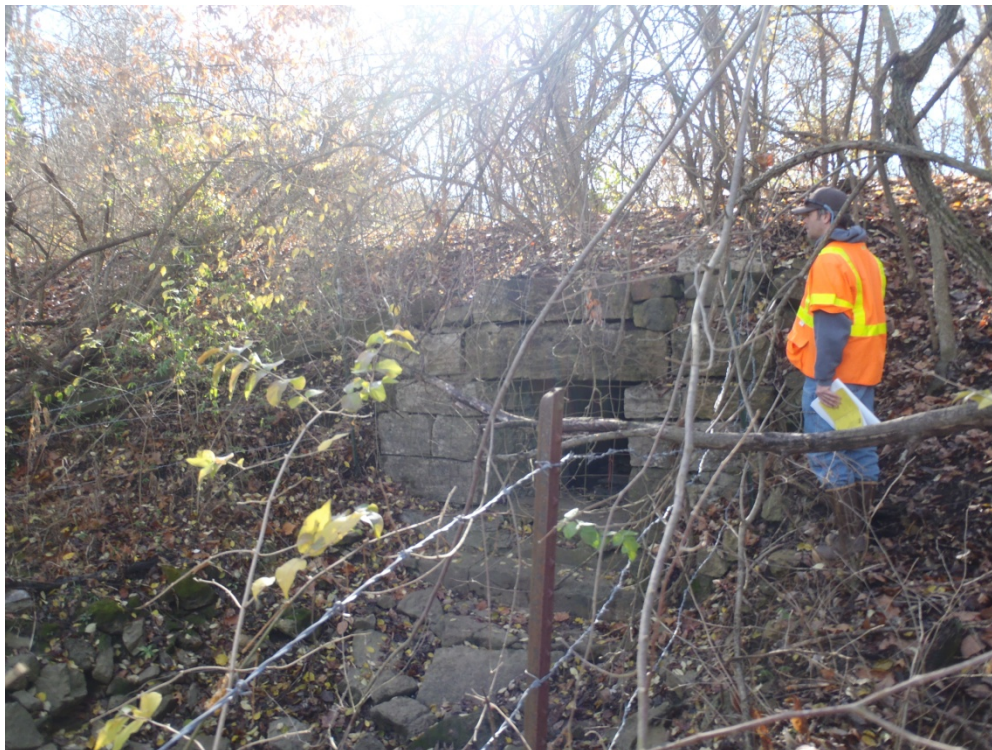
Photo 18: HRR016. Vegetated railroad bed slope on culvert for intermittent tributary to Flat River Creek

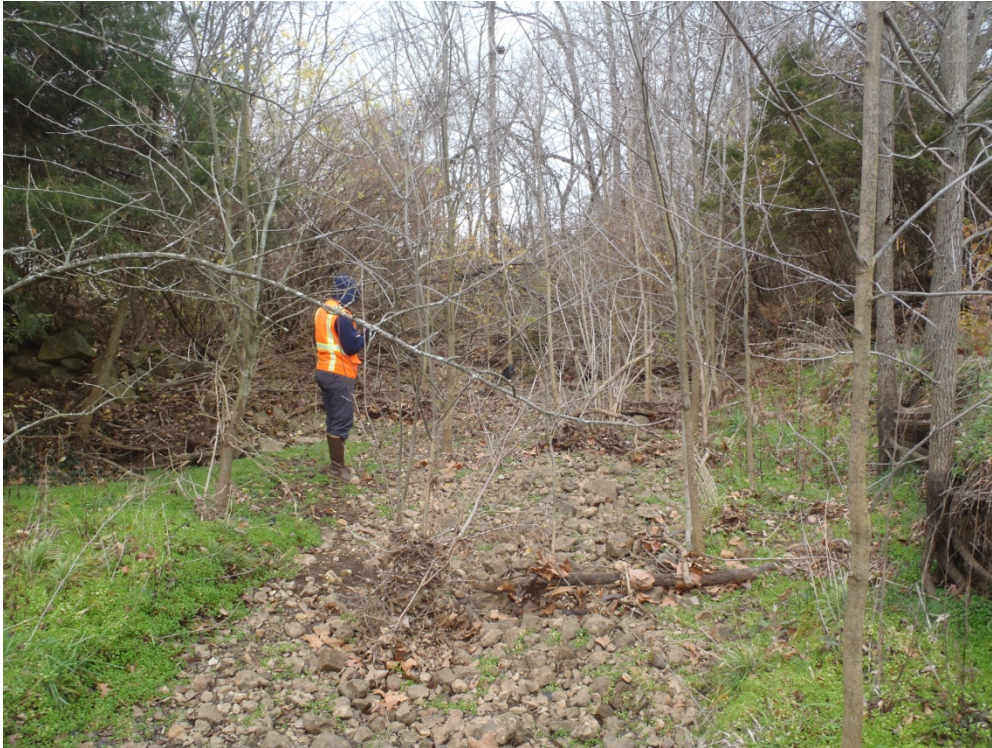
Photo 19: HRR017. Remains of railroad bed near Koen Creek

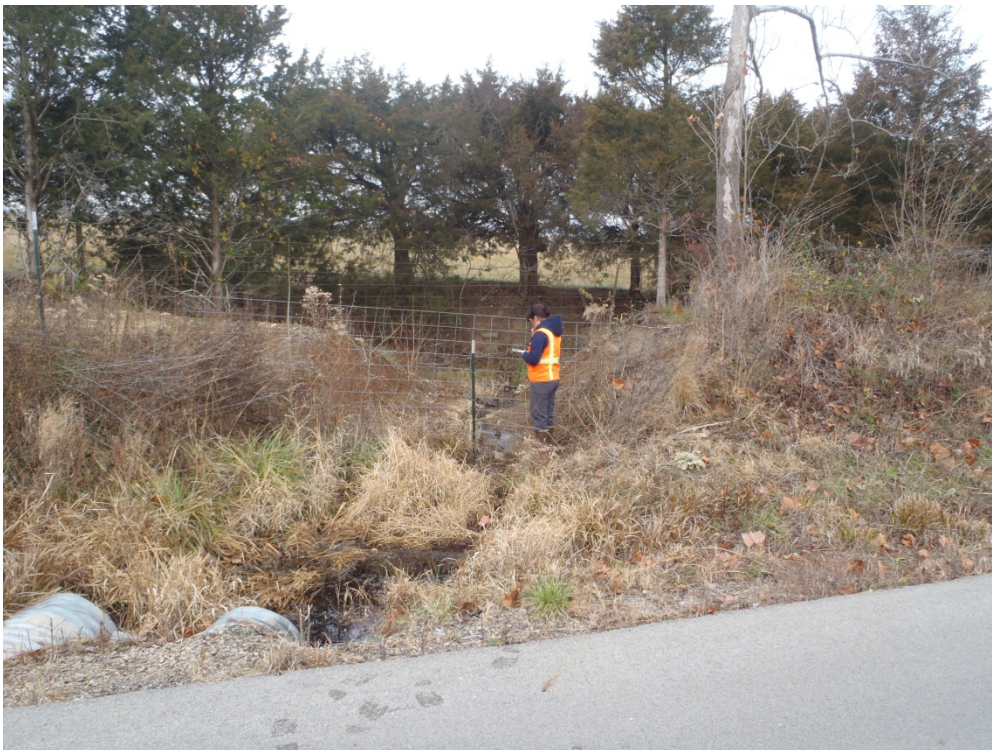
Photo 20: HRR018. Tributary to Koen Creek passing through stable railroad berm

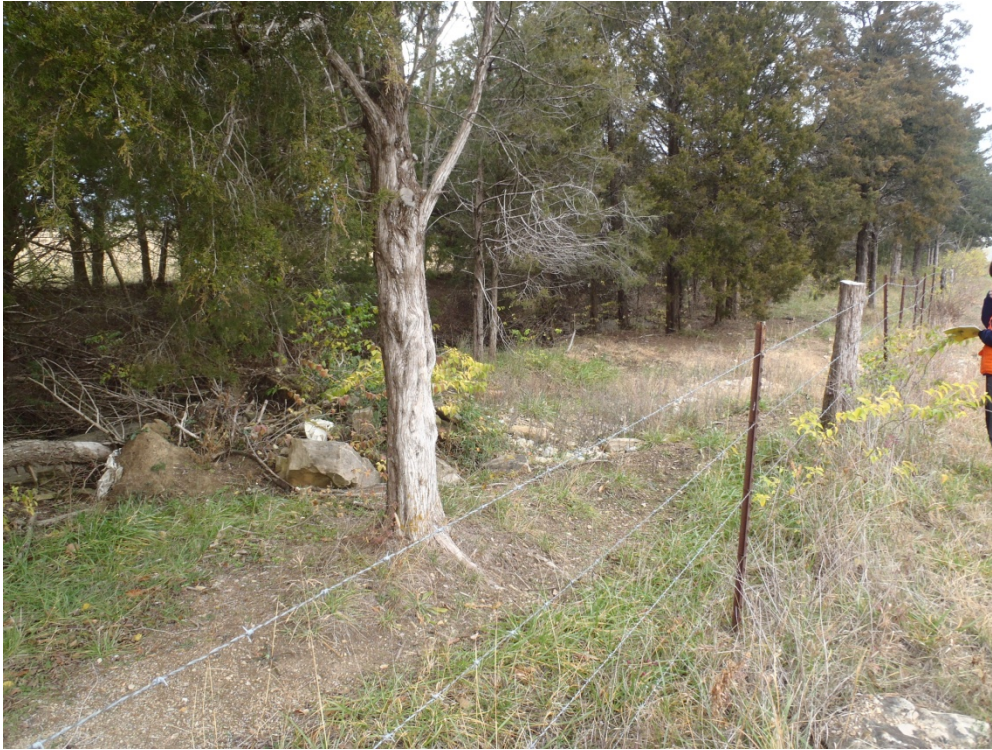
Photo 21: HRR019. Remains of railroad bed near tributary to Koen Creek

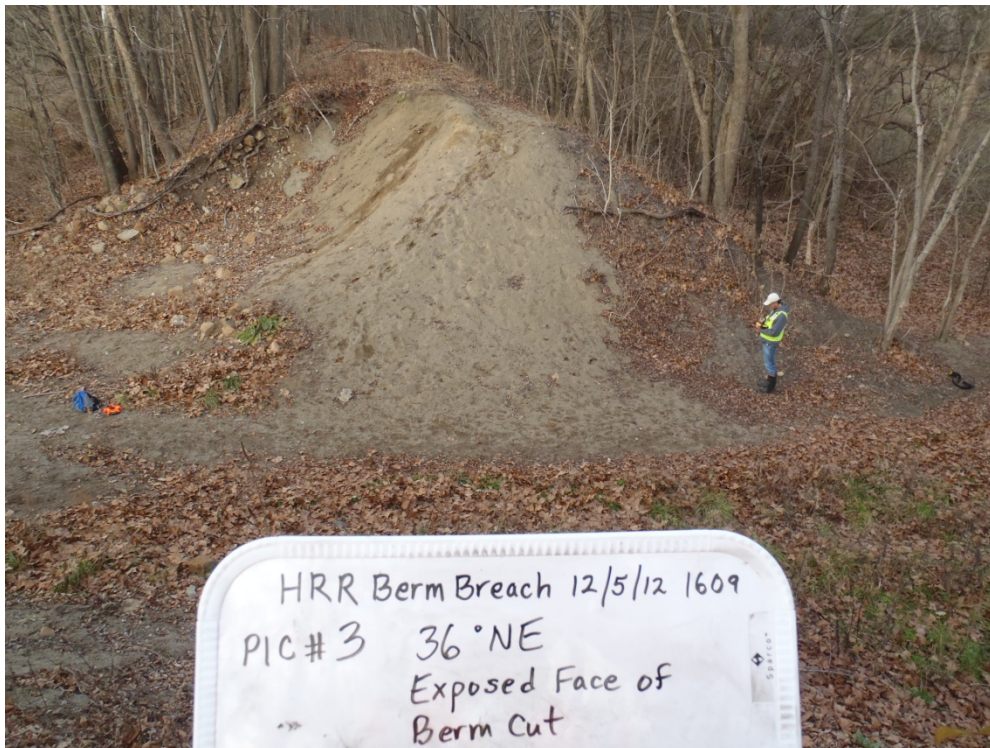
Photo 22: HRR Berm Breach. Breach in railroad bed crossing a field near a Big River tributary
